THE MALDEN SURVEY

A REPORT ON THE CHURCH PLANTS OF
A TYPICAL CITY, SHOWING THE USE
OF THE INTERCHURCH WORLD MOVE-
MENT SCORE CARD AND STANDARDS
FOR RATING CITY CHURCH PLANTS

Copyright 1920 by the
Interchurch World Movement
of North America

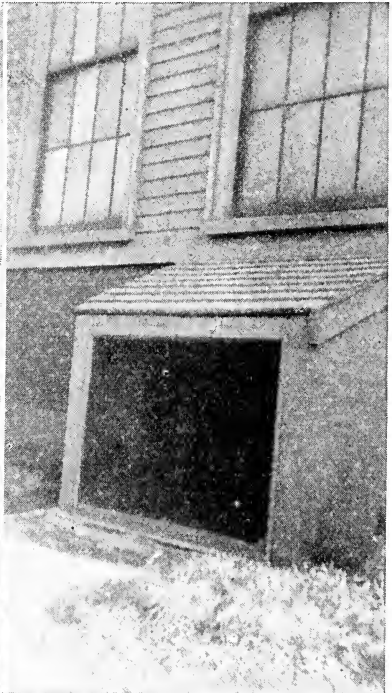
ILLUSTRATION 48. AIR INTAKE OF THE FIRST CONGREGATIONAL CHURCH LOCATED AT GROUND LEVEL

One of the most important standards under this heading concerns the source of fresh air supplied. The standards suggest the following: "The fresh air supply for ventilation should be taken from an uncontaminated source, preferably from above the roof, or at a point at least fifteen feet above the grade level. The air supplied should be free from dust and other impurities."

Illustrations 47, 48 and 49, pages 90 and 91, point out the prevailing arrangement for securing fresh air in the churches which have made provisions for fresh air supply. Such intakes, even though screened, cannot be as desirable as those located sufficiently high above ground level, and cannot prevent the entry of small dirt particles or dust and filth blown directly from sidewalk or alley. Air drawn from ground levels should be filtered or washed. All heated air should be properly humidified before entering large audience rooms. These provisions are expensive and yet are found possible in large plants. It should be borne in mind that a hot, dry air may be the cause of colds and sore throats for a surprisingly large proportion of an audience.

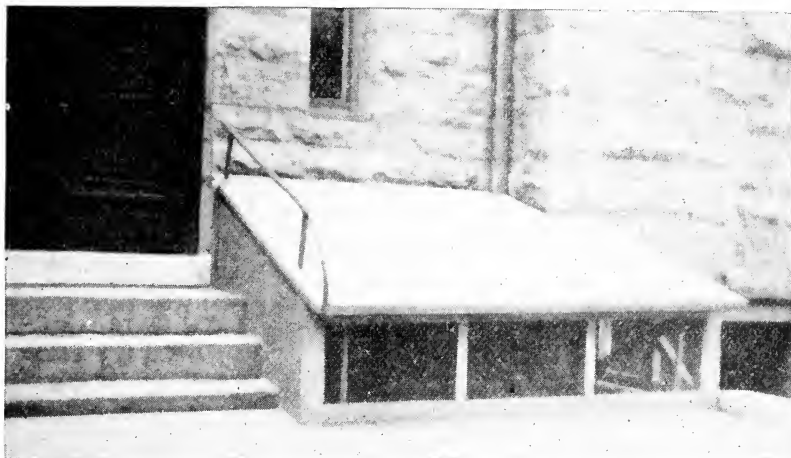
ILLUSTRATION 49. GROUND LEVEL AIR INTAKE OF THE FIRST BAPTIST CHURCH. IT SEEMS UNWISE TO TAKE AIR FROM DUST COVERED WALKS EVEN THOUGH IT IS WASHED BEFORE BEING SENT INTO THE ROOMS ABOVE

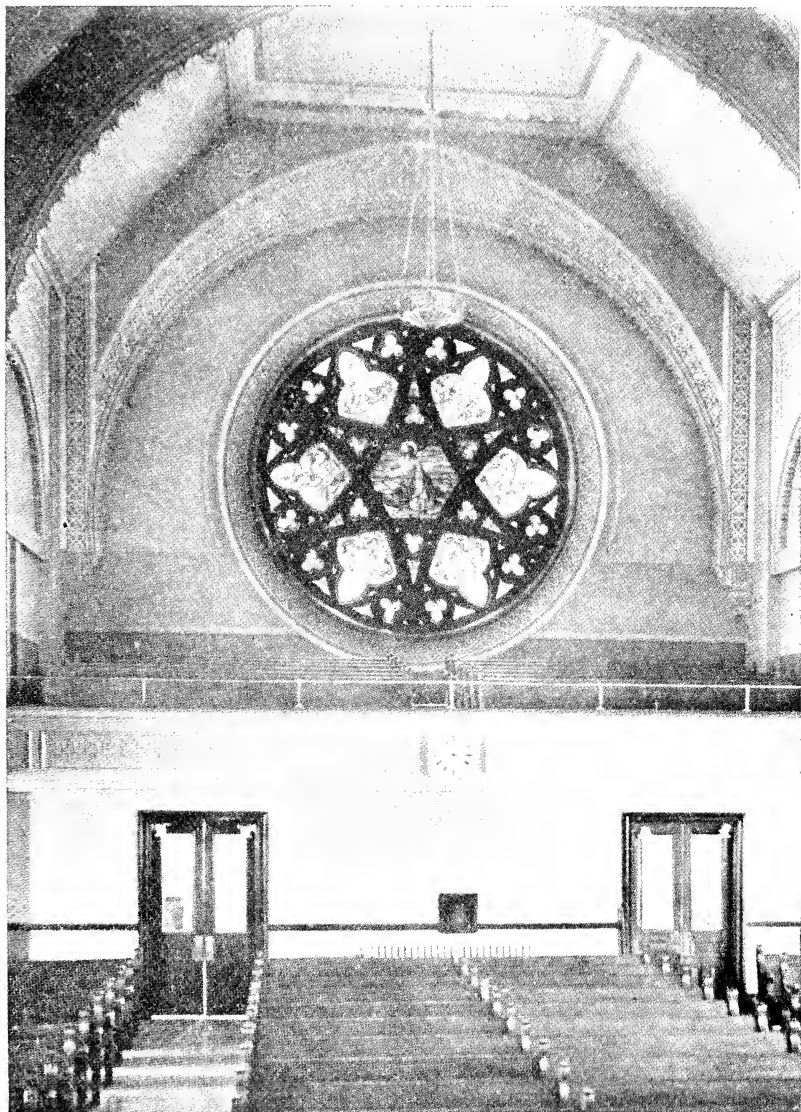
ILLUSTRATION 53. AN ATTRACTIVE INTERIOR OF THE CENTRE METHODIST CHURCH. THIS SHOWS THE SECOND STORY AUDITORIUM FLOOR WITH PART OF ITS THIRD STORY BALCONY, WHERE ABOUT 1000 PEOPLE MAY BE SEATED. AUDITORIUMS, UNLESS IN STRICTLY FIREPROOF BUILDINGS, SHOULD BE AT GROUND LEVEL

Approximately 1,000 people may be seated in the very attractive "second story" auditorium of the Centre Methodist plant, if the balcony and choir gallery are included. The two main and the chief secondary stairways do not permit of sufficiently ready egress for such a throng. Some of this number would be compelled to wait until eighty to one hundred other persons had passed out before they

could reach safety. It is unfortunate that this auditorium has been located as it is. The close proximity of other non-fireproof buildings, the non-fireproof nature of the Centre Methodist structure and the wooden construction of its stairways, as shown in illustrations 25 and 26, page 65, make further precautions for safety quite necessary. Other elements adding to the dangers are the store rooms, and other rooms under the stairways and the fact that the balcony with its seating capacity of 350 to 400 may be considered as being on the third floor.

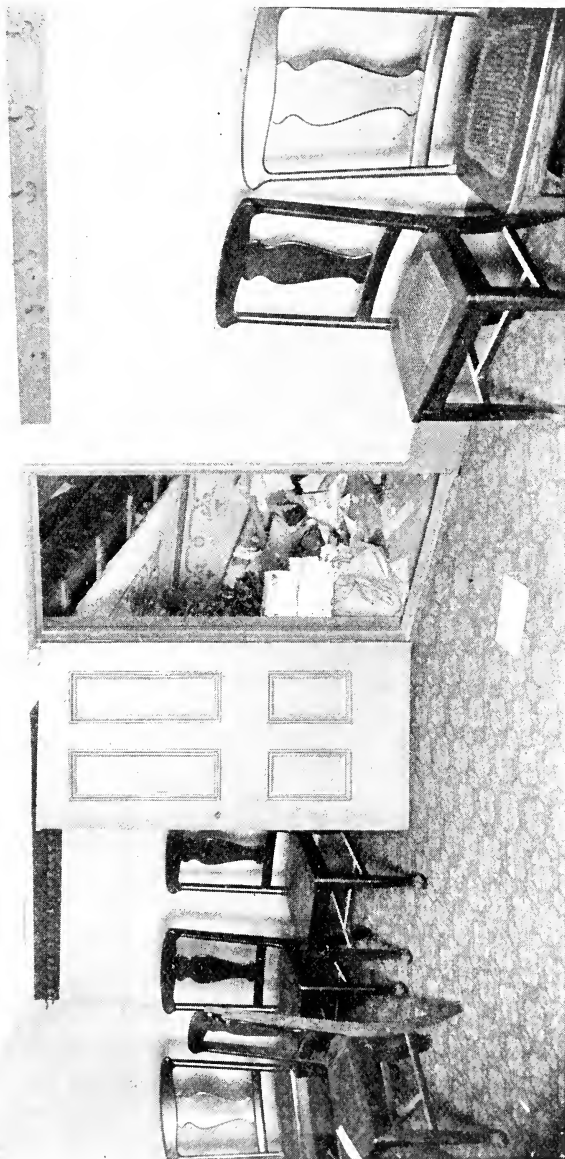
ILLUSTRATION 54. EVIDENCE OF EXTREME DISREGARD OF FIRE DANGERS IN A STORE ROOM DIRECTLY UNDER THE RAFTERS OF THE MAPLEWOOD BAPTIST CHURCH. MUCH EASILY COMBUSTIBLE MATERIAL HAD BEEN TOSSED INTO THIS STORE ROOM

Illustrations 43, page 80, 28, page 65, and 54, page 99, confirm the necessity for this standard. These three pictures lead from a most disreputable basement with every possible fire danger lurking about, to the equally dangerous store room adjoining a class room and located under the partially concealed roof rafters. To be sure, conditions shown in these pictures ought not to be tolerated in any church. Fireproof construction would, on the other hand, ward off the possible results of such disregard for the safety of human beings.

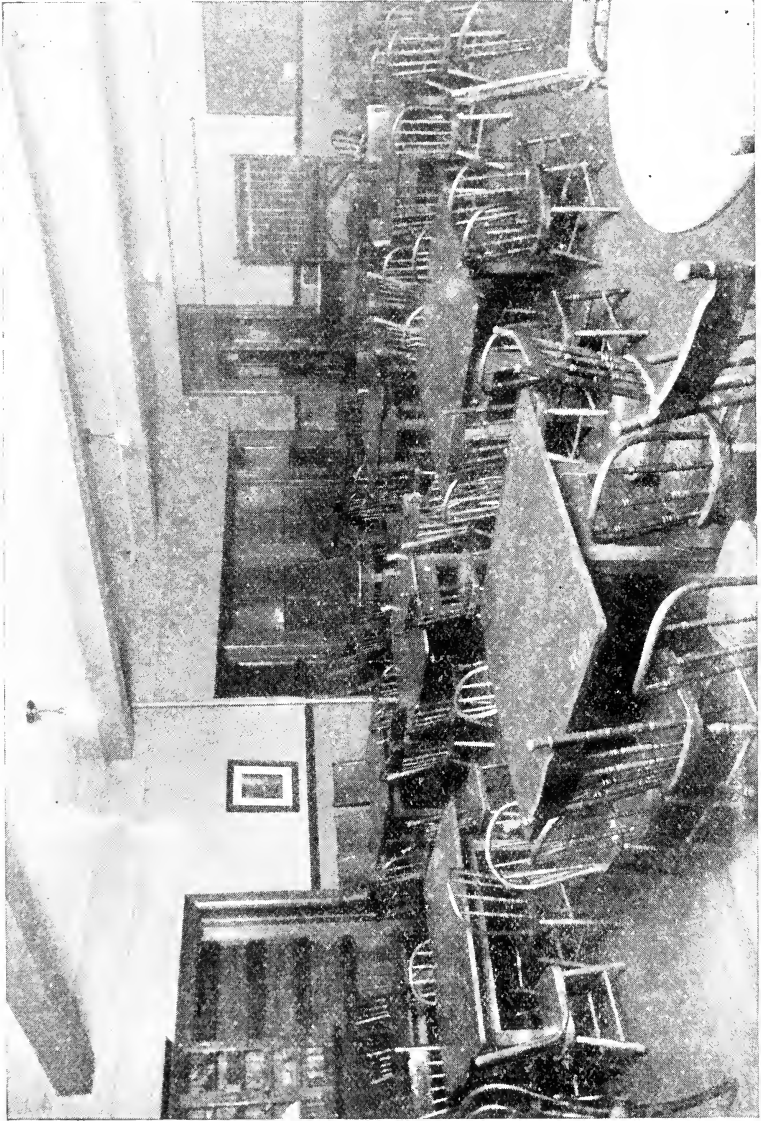
ILLUSTRATION 55. A LARGE SECOND FLOOR CLASS ROOM, CENTRE METHODIST CHURCH
SEE DESCRIPTION ON PAGE 102

No fire escapes have been provided for any of the seventeen churches. The need for such escapes has been pointed out with respect to the churches with "second story" auditoriums. The need is also clear in other instances. In illustration 55, page 100, may be seen a large section of the primary room on the second floor of Centre Methodist plant. This room has many attractive features, but its location on the second floor and its rather unsatisfactory approach detracts from its desirability. The door at the right center is the main exit and under certain conditions it seems that it may be the only exit. The door at the left rear is reported as usually being locked. When opened, no satisfactory outlet is furnished for children at this point. The doors in the center of the picture lead to the low room underneath the choir gallery, used as a cloak-room for the church school. The main exit is through a narrow corridor into which other class rooms empty and down the stairway of illustration 26, page 65, It must be borne in mind that other class rooms on the third floor use this same stairway, that the stairway narrows down at its middle section and that these children belong to the Primary Department. The loose chairs and tables of this room will also add to the difficulty of exit in case of danger.

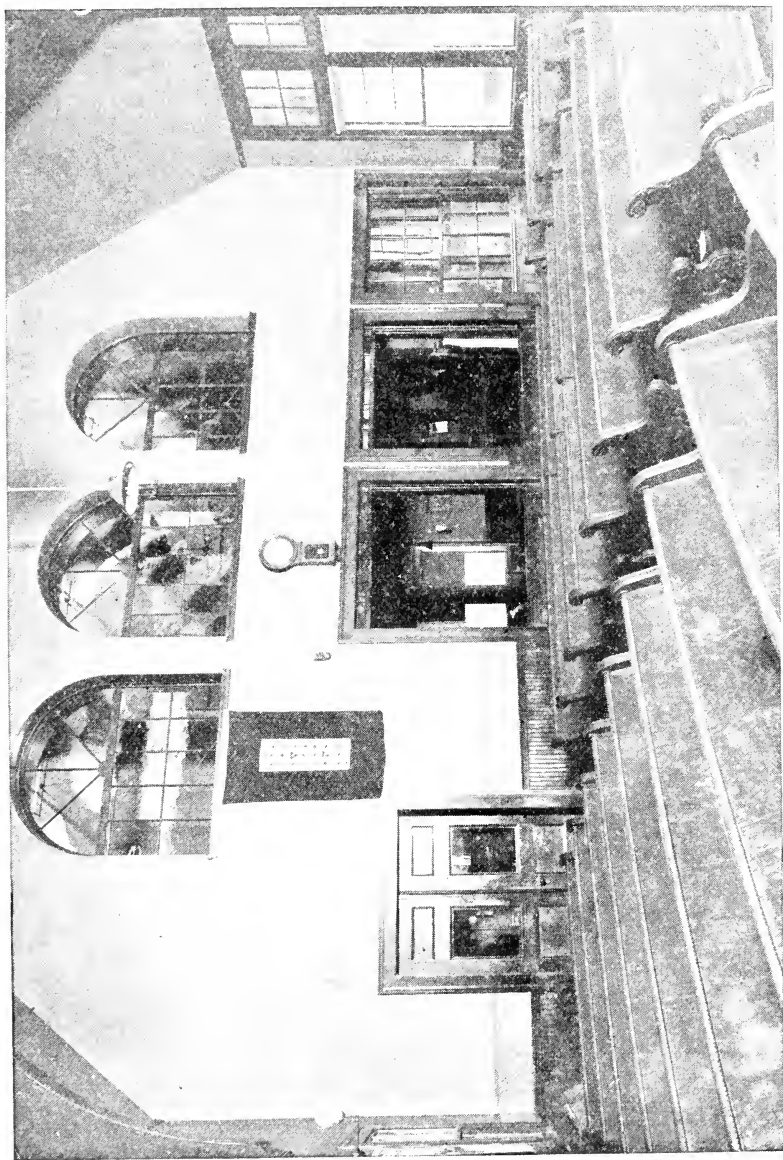
ILLUSTRATION 62. THE AUDITORIUM OF THE MYSTIC SIDE CONGREGATIONAL CHURCH WITH CLASS ROOMS TO THE REAR. WINDOWS IN ROOM ARE RAISED AND CLASS ROOMS USED TO SUPPLEMENT THE AUDITORIUM

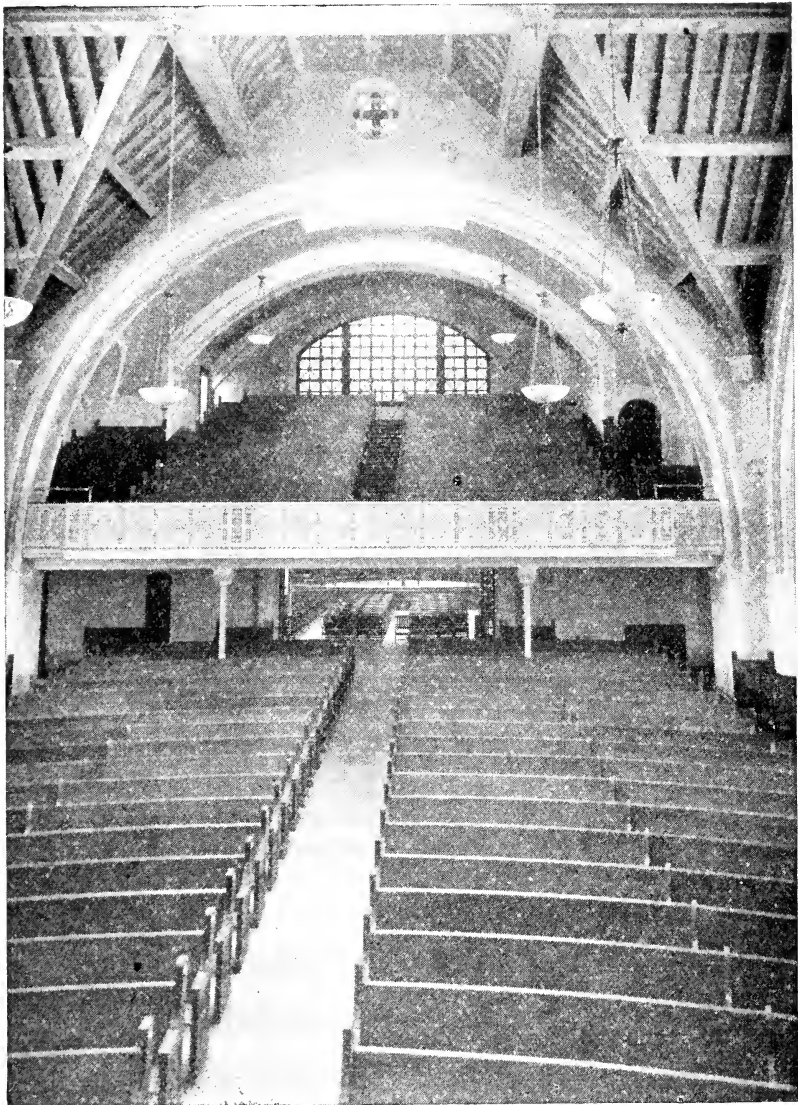
ILLUSTRATION 65. SHOWING THE BALCONY AND DESIRABLE CONNECTION BETWEEN AUDITORIUM AND CHAPEL. FIRST BAPTIST CHURCH

A church auditorium seating less than three hundred people should not have a balcony. Unless the room seats over four hundred, the balcony should be located at the rear of the room. The balcony of the First Baptist Church is inadequate, and it has the disadvantage

of being reached by winding stairways. With the present arrangement, people seated in the upper seats of the balcony face an annoying glare from the auditorium lights. The relation of balcony to auditorium is shown in illustration 65, page 121. The balconies of the Centre Methodist, illustration 53, page 97, and the Maplewood Methodist, are the only two to be given the total possible five points. Several of the churches have small balconies, inaccessible and with poor seating arrangements. One or two show by the conditions of the seats that they are not used.

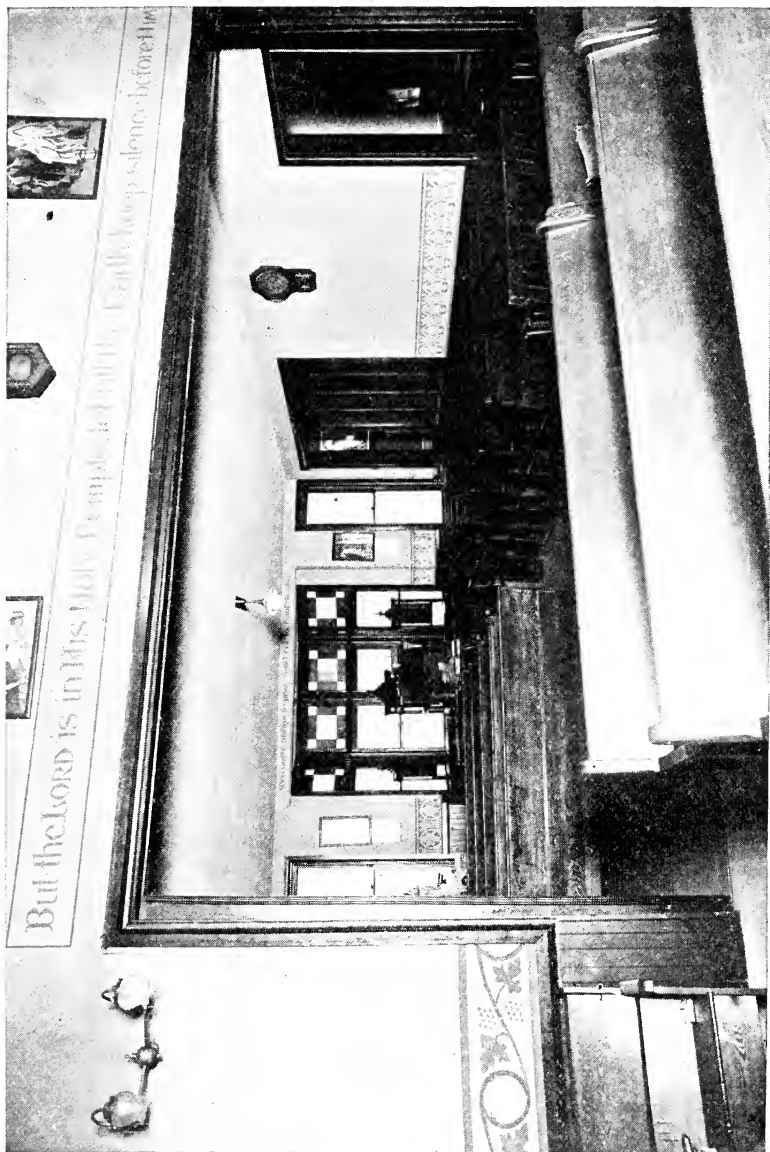
ILLUSTRATION 67. SHOWING CHAPEL OR SMALL ASSEMBLY ROOM OF EASTERN AVENUE BAPTIST CHURCH. NOTE CONVENIENT ARRANGEMENT OF ROOMS. LADIES' PARLOR, PASTOR'S STUDY, LIBRARY, CHURCH OFFICE ALL OPEN INTO THIS ROOM. PLACING OF SEATS MAKE AUDIENCE FACE COLORED WINDOWS

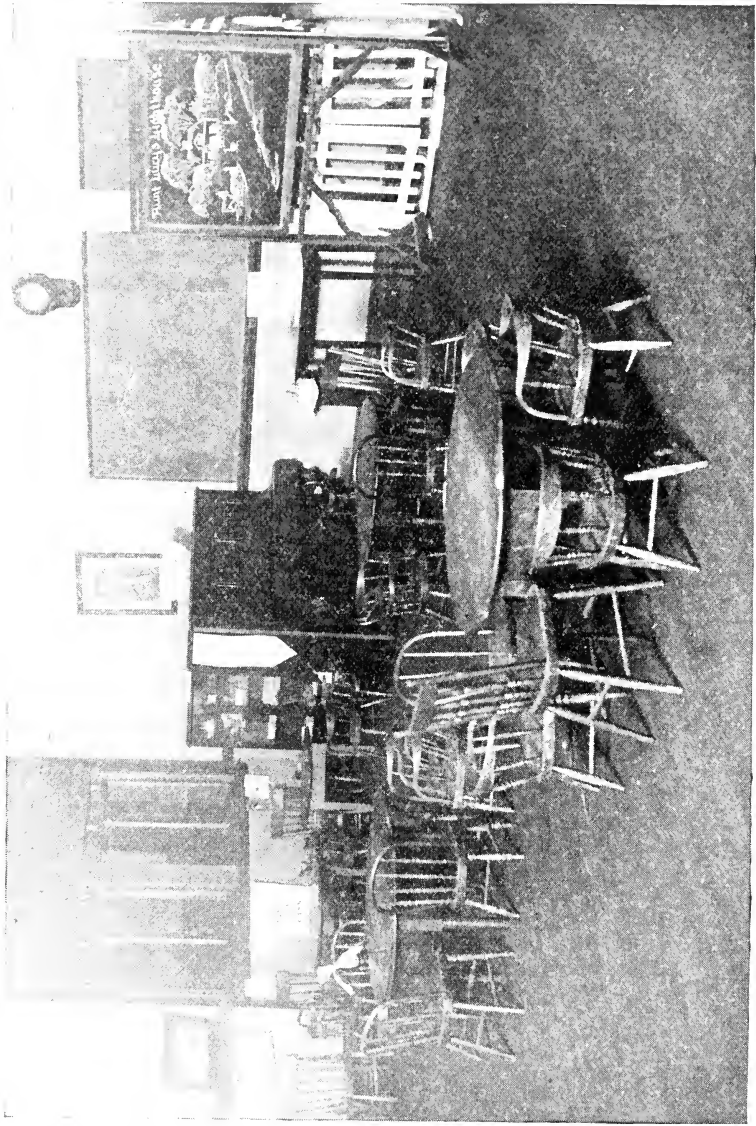
ILLUSTRATION 70. BEGINNERS' CLASS ROOM, CENTRE METHODIST CHURCH. A WELL EQUIPPED CLASS ROOM WITH MANY EVIDENCES OF GOOD TEACHING AND MODERN METHODS. IT IS UNFORTUNATE THAT THIS CLASS ROOM IS LOCATED ON THE SECOND FLOOR

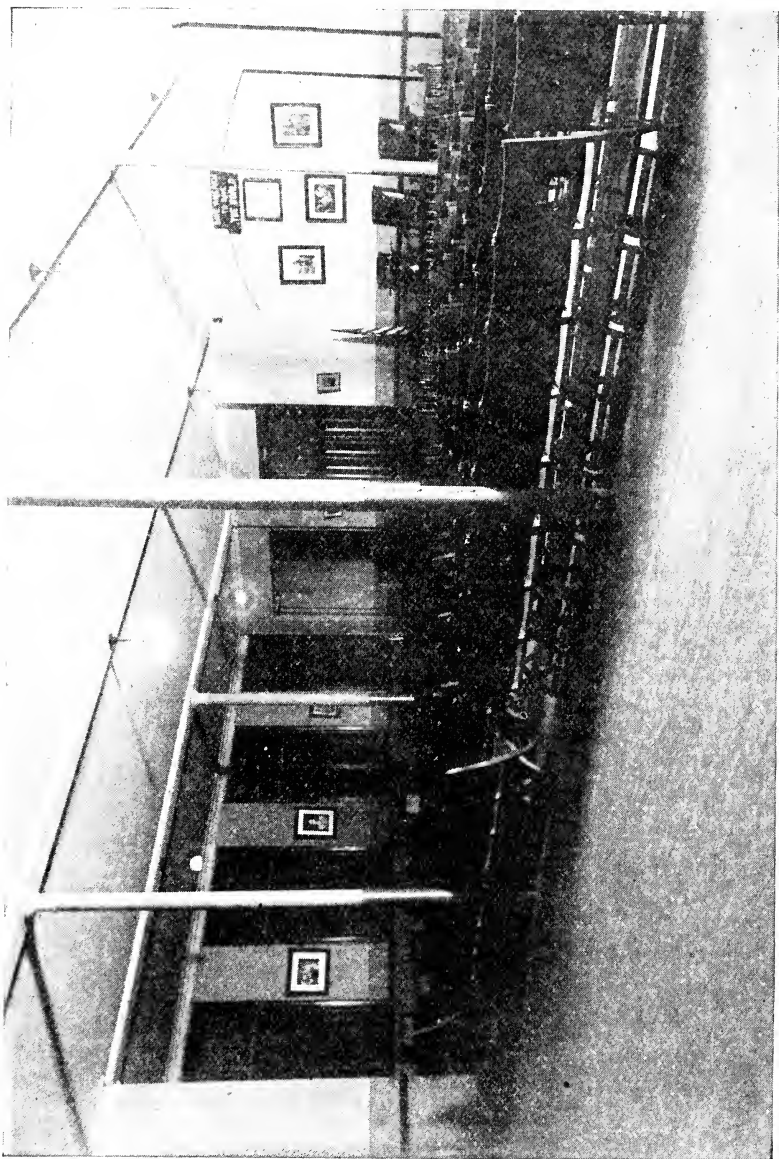
ILLUSTRATION 72. SUNDAY SCHOOL ASSEMBLY ROOM CENTRE METHODIST CHURCH. AT THE RIGHT AND LEFT OF THIS ROOM CLASSES ARE ASSEMBLED ON CHAIRS ABOUT TABLES WITH LITTLE OTHER EQUIPMENT.

The high standards for platform and stage have not been approached. These standards suggest a utilization of the school assembly for pageantry, dramatization and other school and community activities which cannot become possible because of the inadequate provision of the majority of assemblies in the seventeen plants. The highest scores on this item were allotted the First Parish in Malden, Universalist, and the First Baptist plants. These platforms may be seen in illustrations 73 and, 82 pages 141 and 153. The inadequacies of even these situations may be seen by a careful perusal of the standards on pages 197 to 199. The total inadequacy of the "Platform and Stage" of other plants is quite apparent in illustrations 71, 72, 51, pages 137, 139, and 94.

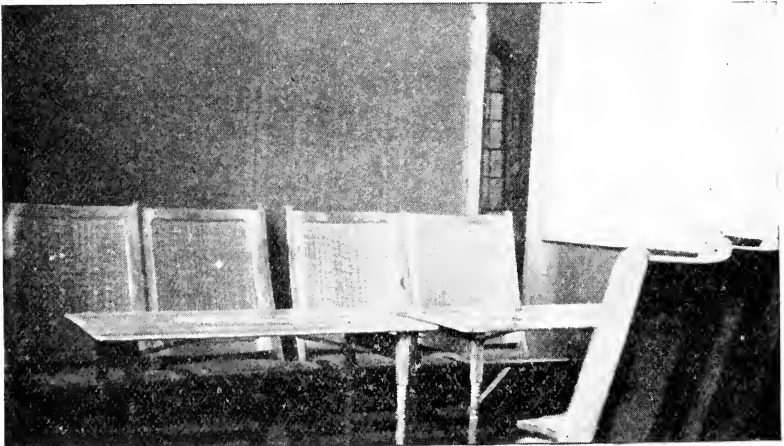
ILLUSTRATION 74. ONE OF SEPARATE CLASS ROOMS MADE BY SCREENS AT THE SIDES OF THE SUNDAY SCHOOL ASSEMBLY OF THE FIRST CONGREGATIONAL CHURCH

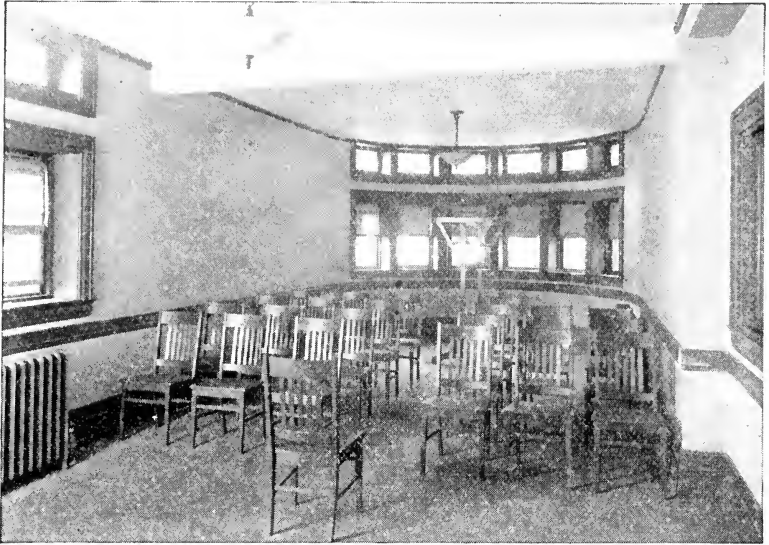
ILLUSTRATION 76. CLASS ROOM OF THE FIRST BAPTIST CHURCH,
EQUIPPED ONLY WITH CHAIRS AND COAT RACKS

A standard class room has doors swinging either outward or having a two-way swing. Even in the most modern plants in Malden this highly desirable standard is not followed. Class rooms should have built-in closets or cases for the storage of books and supplies and where a class room has no built-in closet, a neat cabinet for books, supplies and class exhibits would seem to be indispensable; even in the class rooms like those of illustrations 76 and 70, pages 144 and 132, inadequate provision is made in this matter.

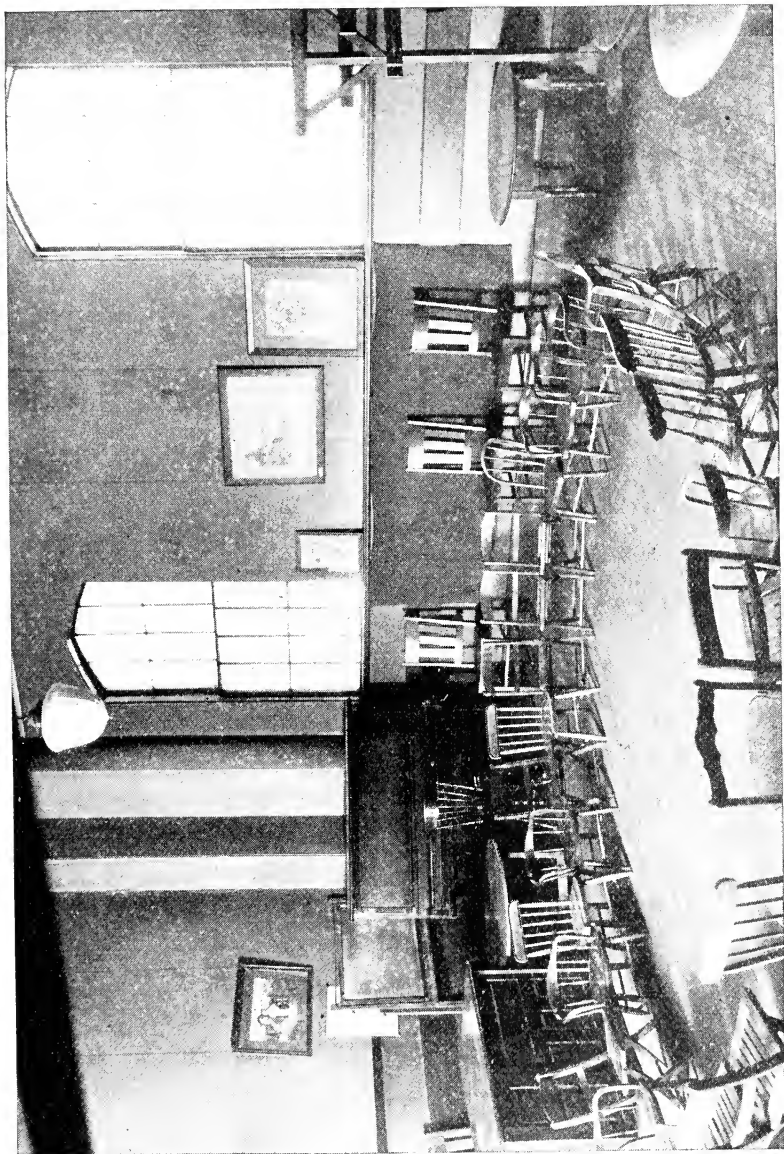
How a well-equipped primary room may be ruined by poor lighting is well shown in the two pictures of the First Congregational Church, illustrations 77 and 21, pages 145 and 57. Viewed by the photographer's flash, the room seems nearly ideal. But through those large windows almost no light comes except at certain times of day; and the second picture shows why. The shadow of the adjoining house falls on the windows like a black curtain, making artificial light a necessity. The church has wisely made this light as soft and pervasive as possible.

ILLUSTRATION 77. PRIMARY CLASS ROOM, FIRST CONGREGATIONAL CHURCH. A WELL ARRANGED AND WELL EQUIPPED ROOM. GOOD ARTIFICIAL LIGHTS OVERCOME THE POOR LIGHT CAUSED BY ADJACENT BUILDINGS. SEE ILLUSTRATION 21, PAGE 57

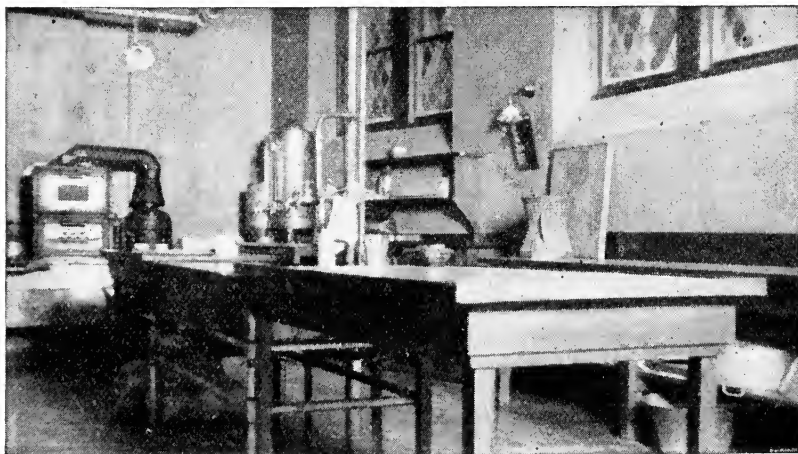
ILLUSTRATION 86. THE FAIRLY WELL EQUIPPED, WELL LIGHTED KITCHEN OF THE FIRST PARISH IN MALDEN, UNIVERSALIST
